24VDC Li Expander Pak 2400 LED Battery Status Monitor

Solar Stik® Technical Bulletin 1A

Effective Date 20150831

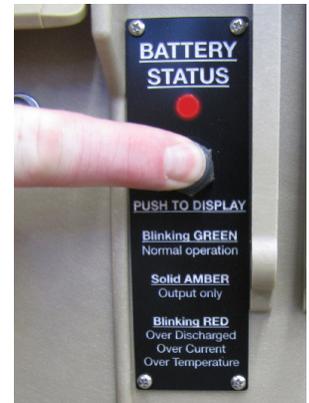
RESOLVING A **RED**-LED CONDITION:

*If only one Li Expander Pak 2400 in the Bank displays a blinking **RED** Battery Status LED, and the situation is resolved fairly quickly after isolating the Li Expander Pak, then the cause of the blinking **RED** LED is most likely an over temperature or over current fault registered by the Li Expander Pak's own internal Battery Management System. When the LED returns to **GREEN** and the Li Expander Pak is reintegrated into the system, the Battery Status should be monitored frequently until it is clear that it will continue to function properly. If the **RED** LED fault reappears quickly after several attempts to clear the **RED** LED fault, then it is likely that the Li Expander Pak should be sent to Solar Stik for assessment, repair, or replacement.

Remove the Li Expander Pak from the AES. Allow the battery to rest with the POWER switch in the ON position for 5 minutes, then check the LED STATUS:

- If the LED is **GREEN**, ensure the ports and connectors for the Li Expander Pak 2400 are clean and that the Inter-Connect cables are in good condition. Then reinstall the Expander Pak into the battery bank and charge normally*.
- If the LED is still **RED**, apply a charging source until the LED turns **GREEN**.
- If the LED remains **RED** after 24 hours of charging, the underlying problem is not the charge level of the battery but rather something internal. If so, the Expander Pak may need to be returned to Solar Stik for assessment, repair, or replacement.

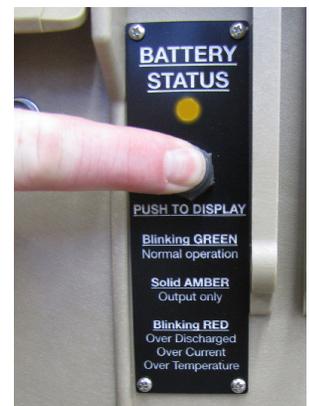
RESOLVING AN **AMBER**-LED CONDITION:

An **AMBER** LED indicates normal behavior. The **AMBER** LED (solid, not flashing) indicates that the Expander Pak battery is fully charged or may have been slightly overcharged. This can occur with individual Expander Paks even when multiple Expander Paks are connected in parallel and cycled together. This is because the fully charged point that exists with this battery chemistry is uniquely balanced by each individual battery's Battery Management System (BMS). If the Li Expander Pak is disconnected from the circuit and either left alone (no load), or a load is placed on the battery, the LED should start to blink **GREEN**.

While the battery BMS has only a solid, non-blinking **AMBER** program in it, a blinking **AMBER** LED indicates that the LED is being turned on and off. This is caused by the Li Expander Pak 2400 battery going into and out of an overcharged condition, and may indicate that the charging voltage of the PRO-Verter or the Power Hub is set too high. The power output of the Expander Pak battery is still functional; however, the battery's BMS is simply protecting itself from any more charge going into it.

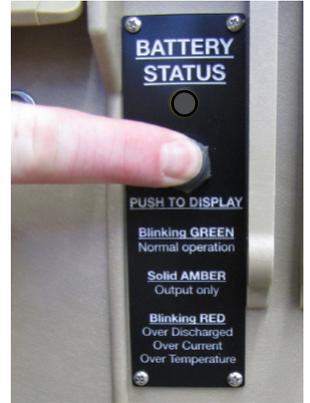
A reading of 20.0 volts (which is the “terminal disconnect voltage”) or less indicates that the battery BMS has disconnected the batteries. The LED will report the status of the battery less frequently as the BMS reduces activity to reduce the draw from the battery. “Phantom voltages” may also be observed. These may be variable and are not an indication that the BMS has reconnected the batteries to the Inter-Connect terminal.

1. Turn on the master breaker (“Power”) switch and measure the voltage across the terminals of the Inter-Connect port.

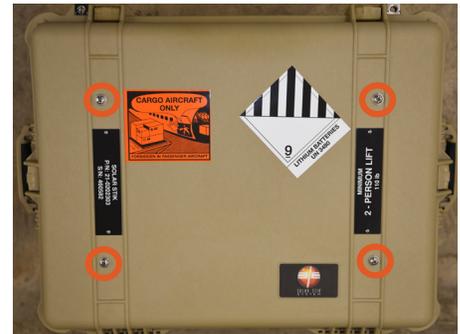
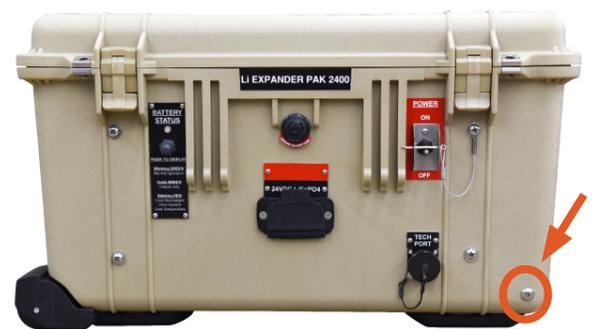
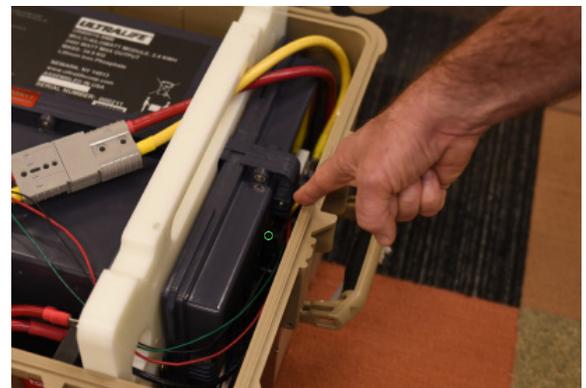
It should be flashing **GREEN** if the battery is charged—or at least the voltage is above 20.0 volts. If this LED is flashing, the issue with the Status Indicator LED on the front of the Li Expander Pak 2400 is “downstream” from that point.

With the Power Switch in the OFF position, open the lid and immediately, visually inspect the interior of the case for damage or water or particulate intrusion.

If water has pooled in the interior, keep the Expander Pak on a flat surface to prevent water from deep-pooling at the low end of the tilt. This could cause submersion and damage to internal parts. Remove the drain plug and let the water drain until it stops. Then **slowly and carefully** tilt the Li Expander Pak toward the drain hole until the pooled water is gone.

If water has condensed on any surface, carefully dry the water with a nonconductive cloth.

Let any remaining water evaporate until the interior is dry.

4. Visually confirm that the MKM battery, BMS indicator, LED light is working properly.

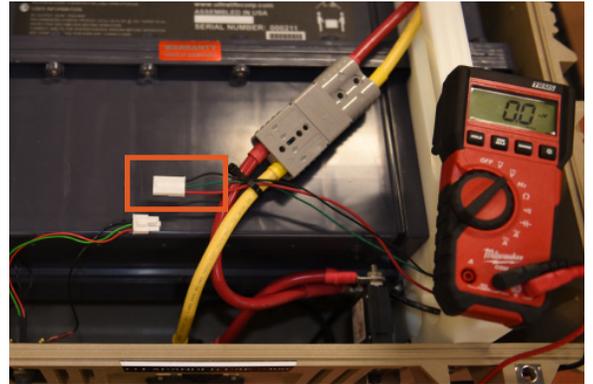
NOTE: The thicker gauge of some lead probes can make it difficult to make electrical contact inside of the connector. If a zero (0) reading is observed, ensure that it is not due to failure to make electrical contact.

6. Measure the voltage across each of the wires.

Insert the probes into the holes of the battery side (male-end) Molex connector. Measure: Red to black and green to black. These should produce intermittent voltages of ≤ 2.0 mV. If these voltages are present at these points, move to the next step.
